Tibbetts Creek Streambank Revegetation

Lakeshore Enhancement

Sunset Beach Wetland Restoration

Pond Habitat Improvement

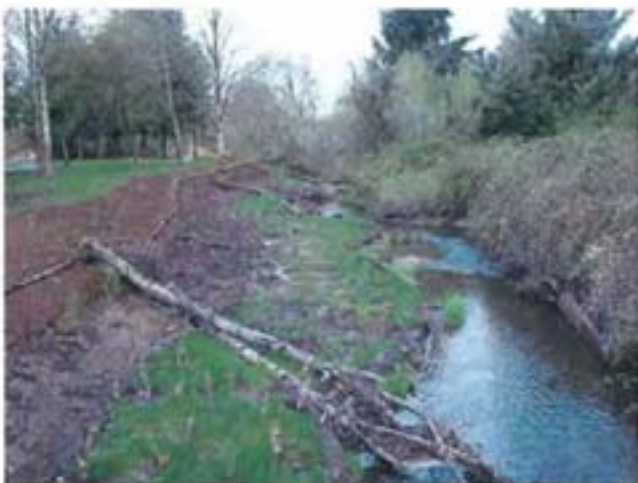
Himalayan Blackberry along existing streambank

This proposed project would expand and complete the riparian restoration along Tibbetts Creek (without further grading) to include the right stream bank for those stream sections included in the previous WSDOT project. Elements of this proposed project include Himalayan blackberry removal, with ongoing monitoring and the removal of regrowth, and the removal of unnatural debris, especially remnants of an old silt fabric fence. Once the streambank has been so-prepared, native vegetation will also be planted along the

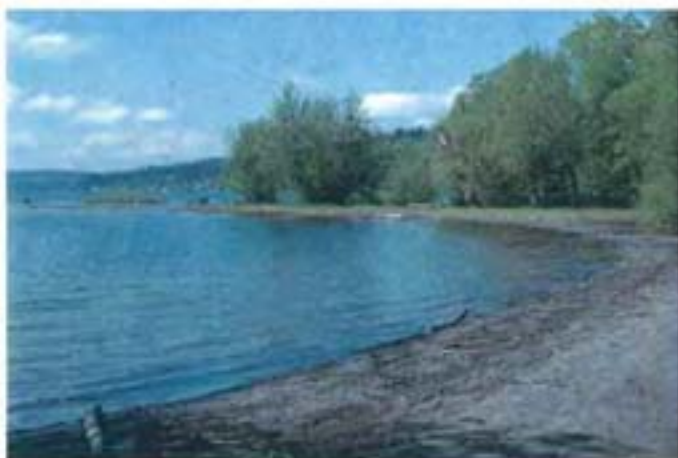
Lakeshore near the mouth of Issaquah Creek

The lakeshore extending from the north side of Sunset Beach to the mouth of Issaquah Creek is a mosaic of wetland and upland conditions. This predominantly sandy area has scattered willows, red-osier dogwood, red alder and black cottonwood trees, some covered with English ivy. It is a high use area of the park, popular with hikers, swimmers, dog walkers, and jet skiers.

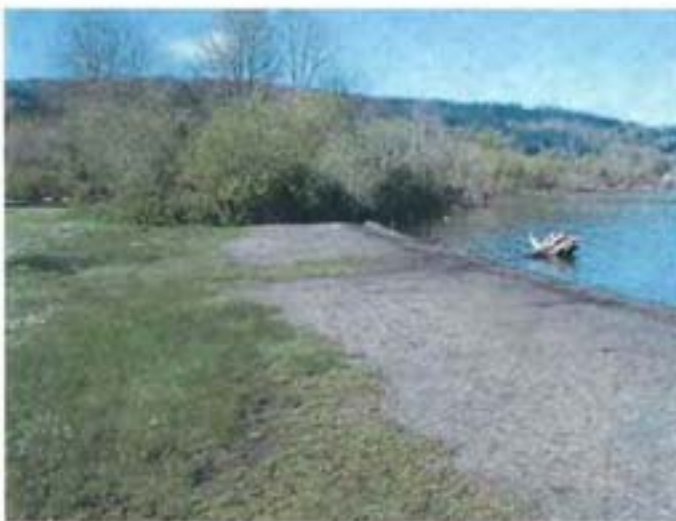
Existing beach is actually a functioning wetland

The northeast side of the lakeshore wetland is a very low quality, disturbed area dominated by lawn grasses, spike rush, and weeds. Although identified as jurisdictional wetland (part of Wetland 5A in Wetlands Inventory for the Lake Sammamish State Park Property (The Coot Company, 2005)), this wetland area is more like the beach than the more natural wetland to the west.

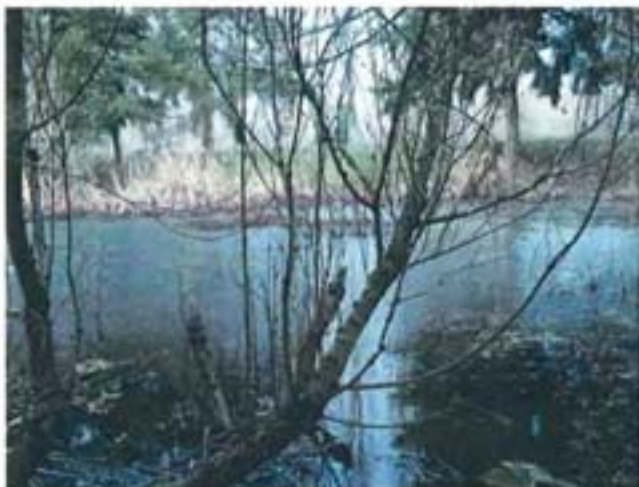
Existing pond edged by reed canarygrass

There is a relatively small pond (0.27 acres) along the southwest side of the New Beach parking lot. This detention pond is adjacent to an existing trail from the parking lot, which crosses Tibbetts Creek on a footbridge, and directs people to the baseball fields. Presently, there is a fairly diverse plant community associated with the pond including Douglas fir, red alder and willows, with mostly blackberries in the shrub layer. Emergent and aquatic plants include cattail, yellow iris, slough sedge, lady fern, soft rush, and water smartweed. The pond edges and surrounding buffer areas are mostly lawn grasses, reed canarygrass, creeping buttercup, and birds-foot trefoil.

Because this pond is in a very visible location, improvements are proposed to increase wildlife habitat values while preserving the outlook to the pond from the adjacent trail and park bench. Edge habitat could be increased and improved, and a more effective buffer could be developed. Blackberries, reed canarygrass, and other weedy species along the edges of the pond should be removed and replaced with a variety of native trees and shrubs that would increase edge habitat and food and cover values for wildlife. Low-

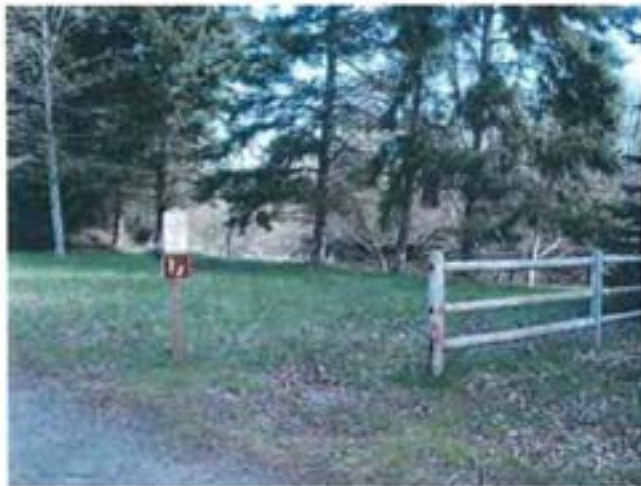
Issaquah Creek streambank near Sunset Beach

Near the mouth of Issaquah Creek along the trail on the left (west) bank is an open area bordering the creek. The site includes two live conifers and a snag along the bank, which is otherwise vegetated almost exclusively with reed canarygrass. The area is approximately 105 feet long by 40 feet wide, extending downstream from an existing fence. Proposed project improvements for this area would entail revegetation with native plant species, possibly retaining a viewpoint.

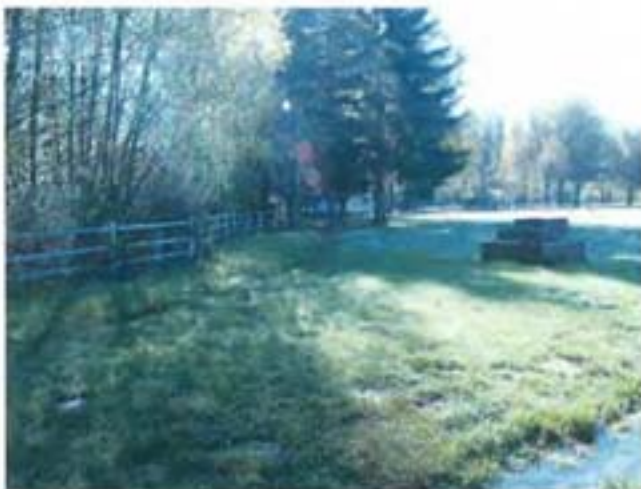
Issaquah Creek streambank near footbridge

Upstream of the Issaquah Creek footbridge along the left (southwest) streambank, the existing parking lot leaves little space available to provide a well-functioning buffer for the creek. Downstream of the footbridge along the same bank, beginning at the stream, is a rail fence in need of repair, a trail through an open conifer forest, and an enclosed volleyball/picnic area. An open, grassy area occupies the would-be stream buffer areas extending farther downstream to the west.

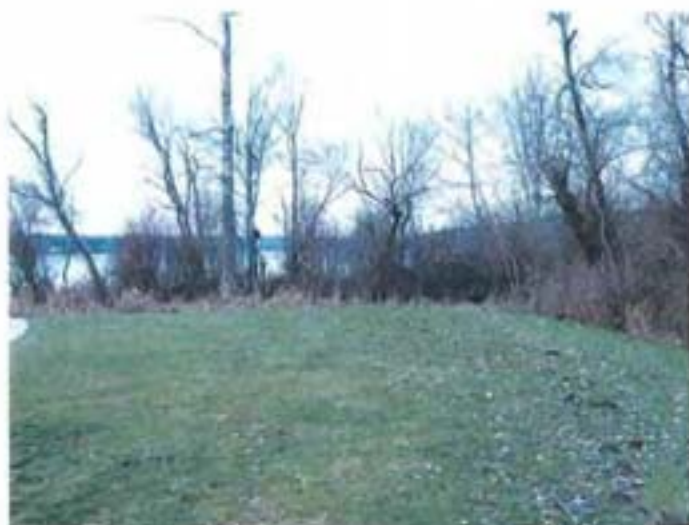
Existing wetland buffer

There is essentially no wetland buffer adjacent to the lakeshore wetland between New Beach and Sunset Beach. The west side is presently mowed grass and sand. This wetland was identified as Wetland 5A in Wetlands Inventory for the Lake Sammamish State Park Property (The Coot Company, 2005).

Wetland buffer plantings should be installed to create additional edge habitat and a more diverse plant community. Conifers, in particular, are lacking in this area, and the addition of firs and cedars would enhance the habitat diversity. There is space for an approximately 25-foot wide buffer area on a hummock between the beach and the wetland. This area could be extended around the wetland as far as possible to the east. Interpretive signage along the trail could be installed to explain the improvements and provide information about habitat features. Fencing should be installed as needed and at least until plantings have become established. This project could be combined with Projects A3 and A12, which also address features of the lakeshore wetland.

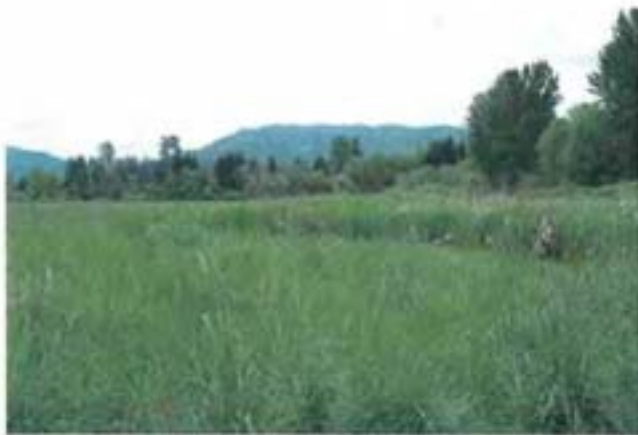
Existing open field lacks habitat values
